# US Bike Route 76

2014 New River Valley Report

# US Bike Route 76 - 2014 New River Valley Report

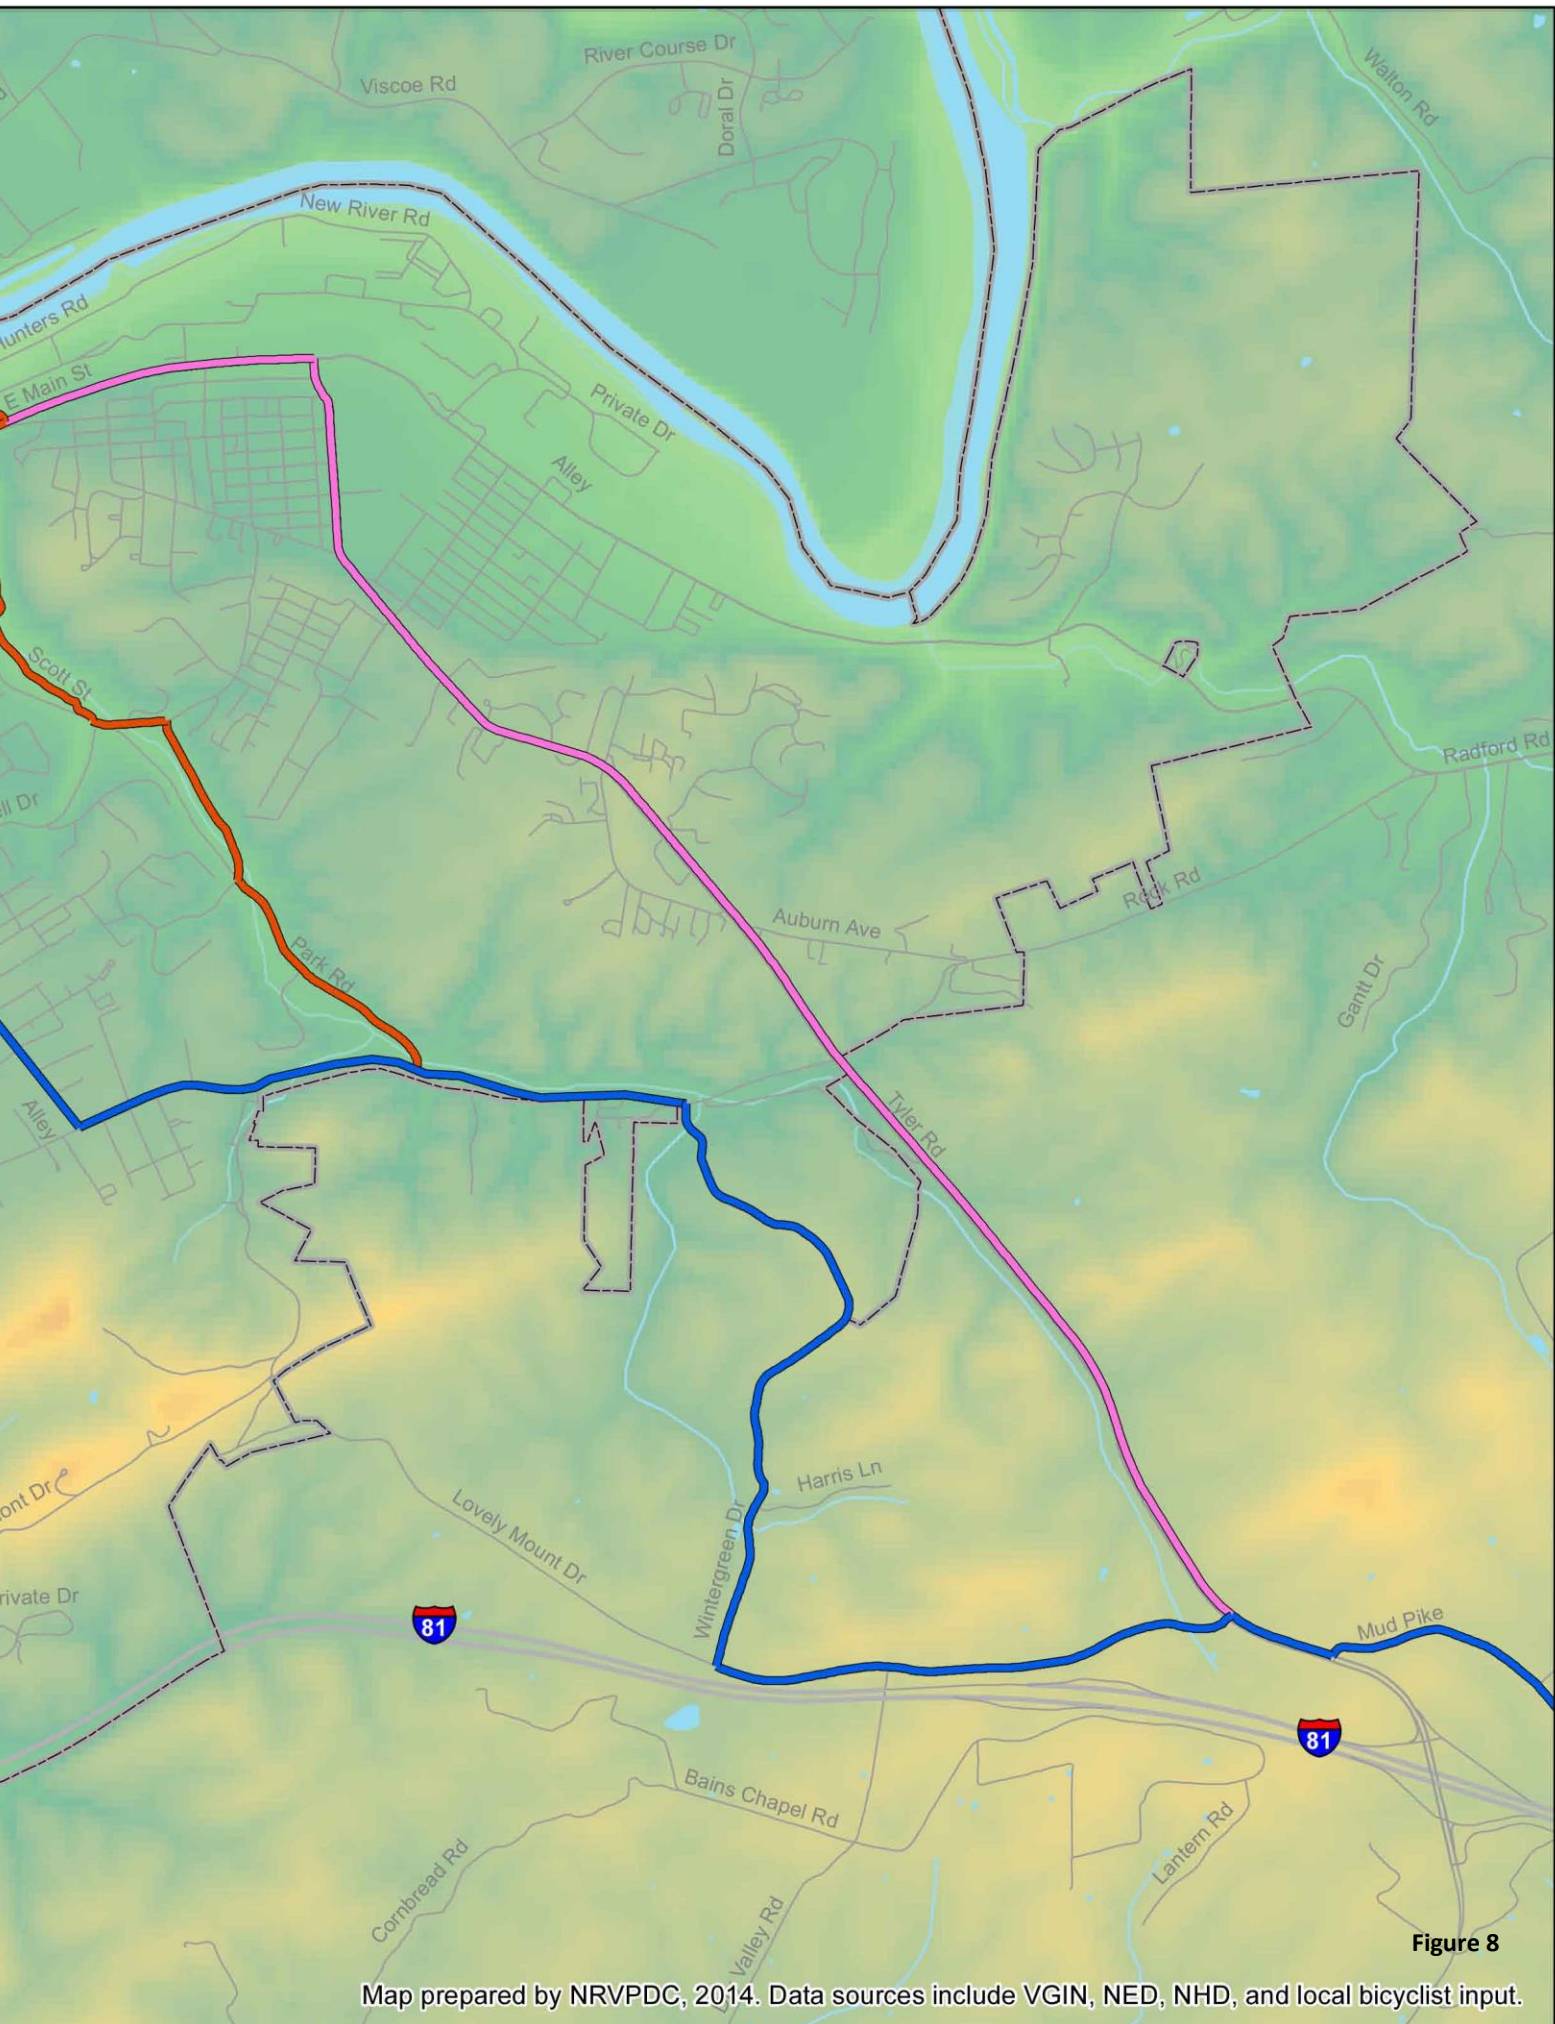
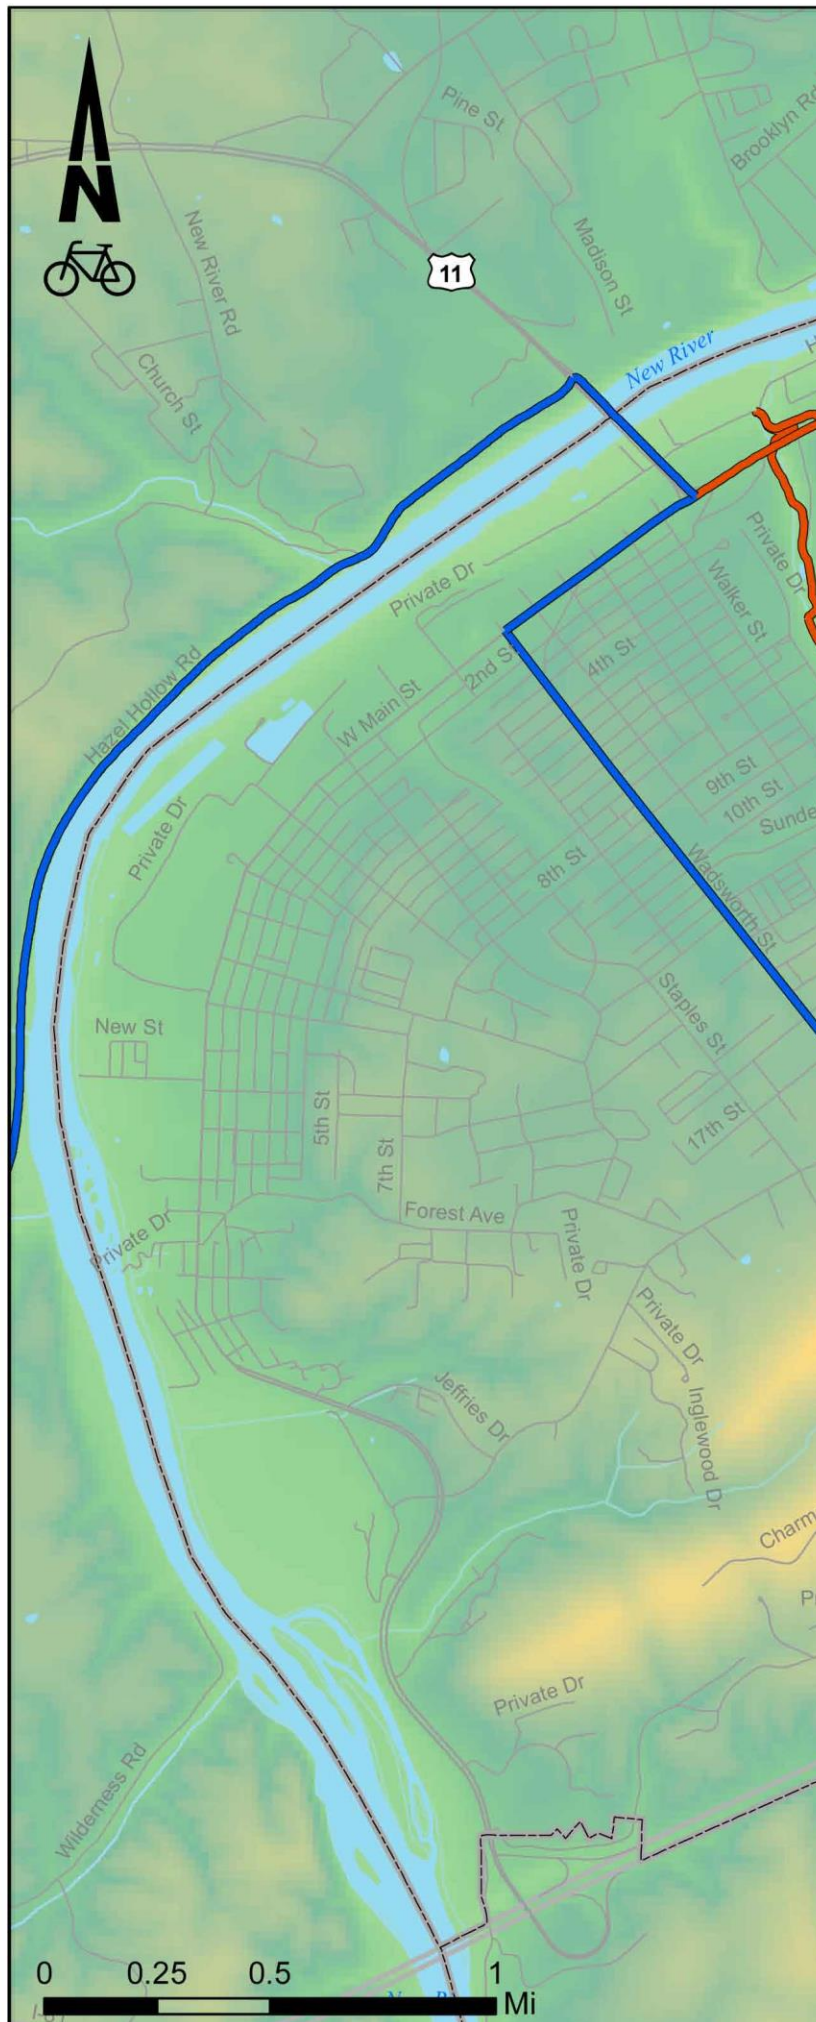
Figure 8 highlights existing route variations between information sources and on the ground signage. The alignment through the New River Valley predominantly avoids downtown areas – which could be a missed opportunity to attract long-distance cyclists to local restaurants, hotels, etc. Regional partners should evaluate options to attract long-distance cyclists into their communities.

- 2) Determine if the existing signed route aligns with the latest mapping:
  - a. Route discrepancies were found in the Radford Area. Route adjustments should be communicated with existing partners and signage adjusted accordingly. Communicating route/mapping discrepancies between existing stakeholders is a short-term goal.

- b. Analyzing alternative routes might be warranted in the Radford Area.
- 3) Review the existing roadway conditions and route selection:
  - a. The Commission should continue to work with cyclists to identify specific locations that have the most significant safety concerns.
